St Croix Home Inspections

Property Inspection Report

461 Ocean Blvd., Christiansted VI, 00820
Inspection prepared for: Mr. & Mrs. Smith
Inspection Date: 8/5/2009 Time: 10:00 AM
Age: 1994 Size: 1800 Sq Ft
Weather: Clear

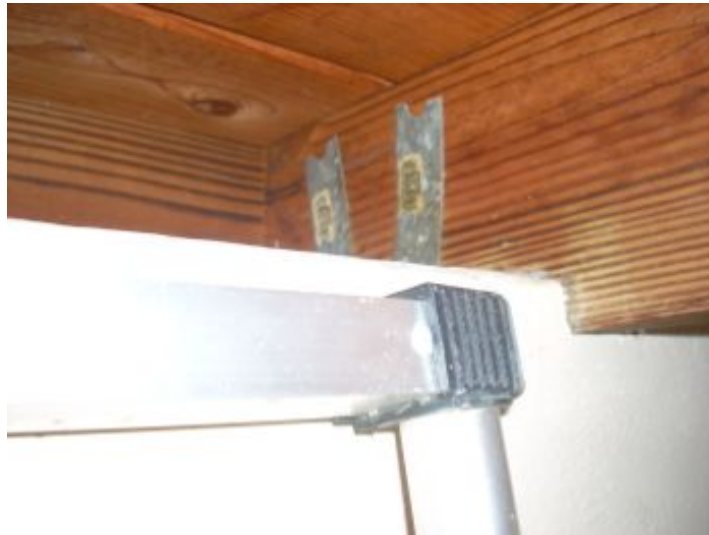
9. Ceiling Condition

Example of double straps on rafters

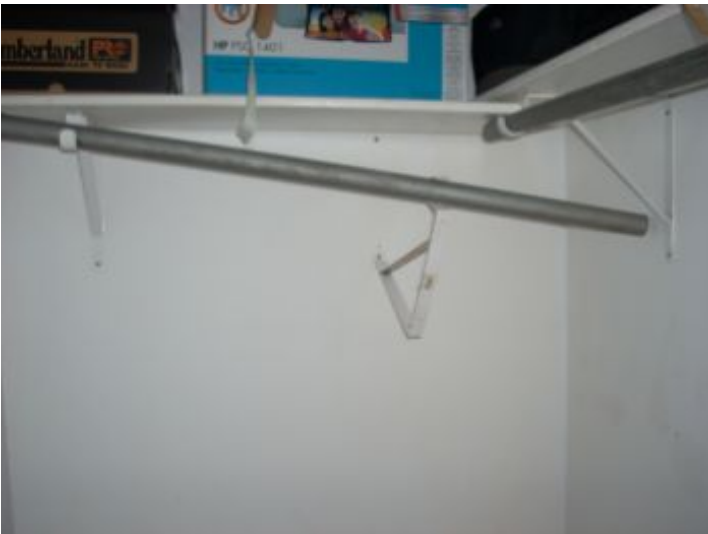
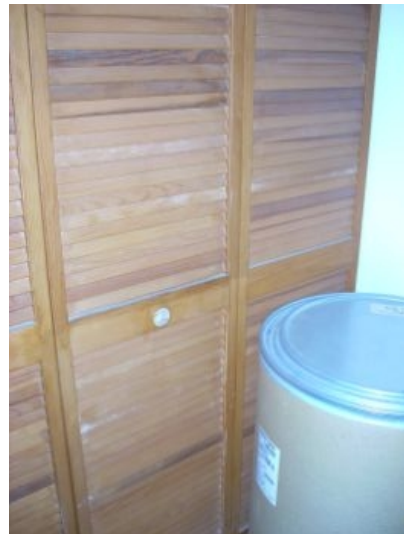
5. Closets

- The closet rod in master needs to be refastened to the wall.

Broken rod

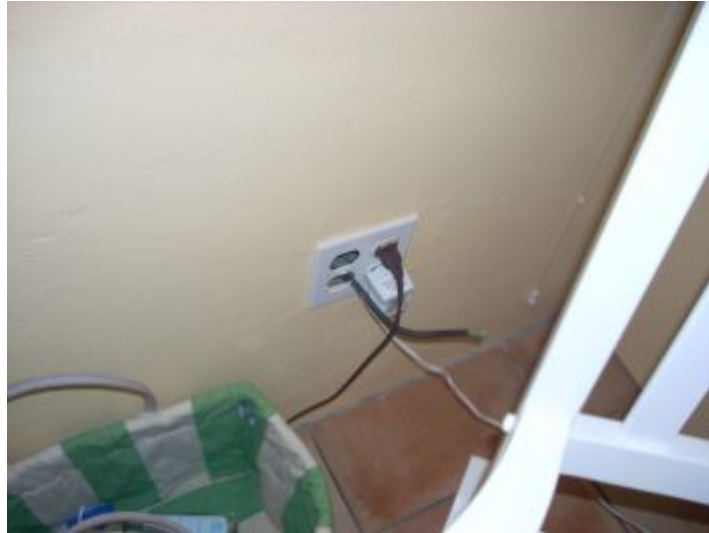
7. Electrical

Cable (low voltage) and 110v in same junction box

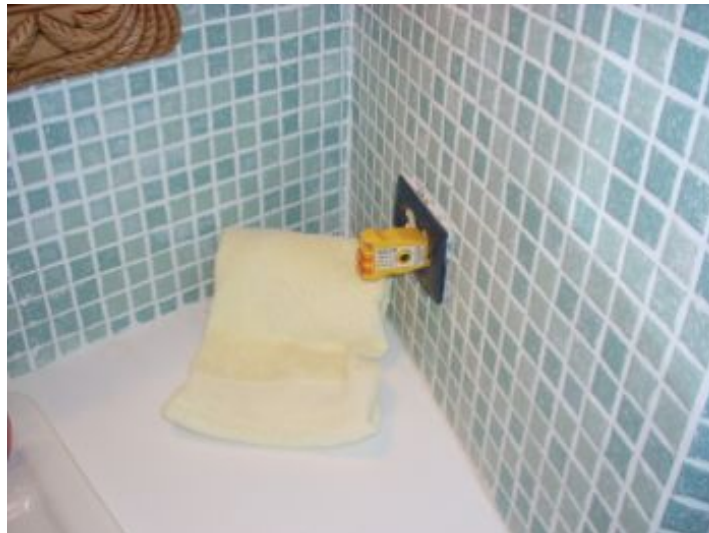
7. GFCI

Observations:
 • No GFCI protection present in bathrooms 2 and 3, suggest installing GFCI protected receptacles for safety.

No GFCI in Master Bath

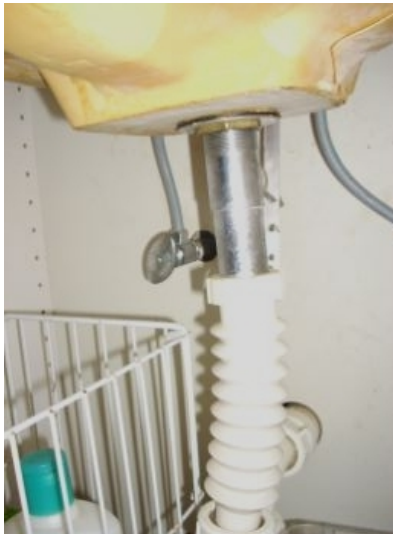
11. Plumbing

- Flex drain observed, these are subject to frequent clogging.

Flex line on guest bath

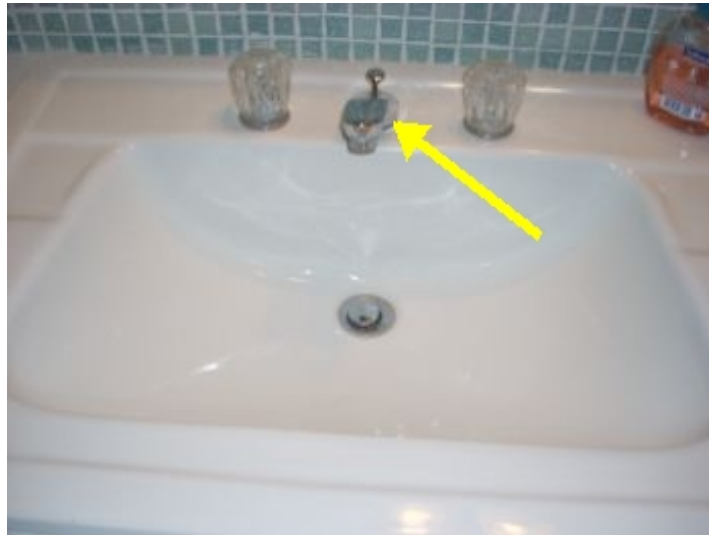
14. Sinks

Faucet is loose

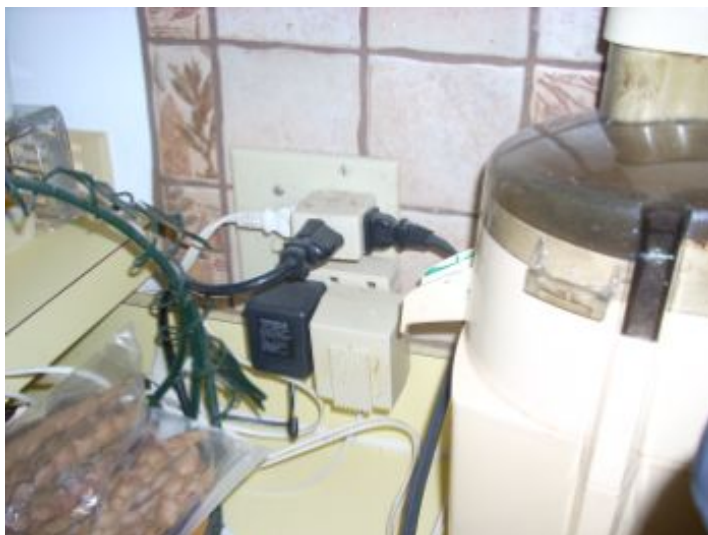
19. Electrical

Outlet overloaded

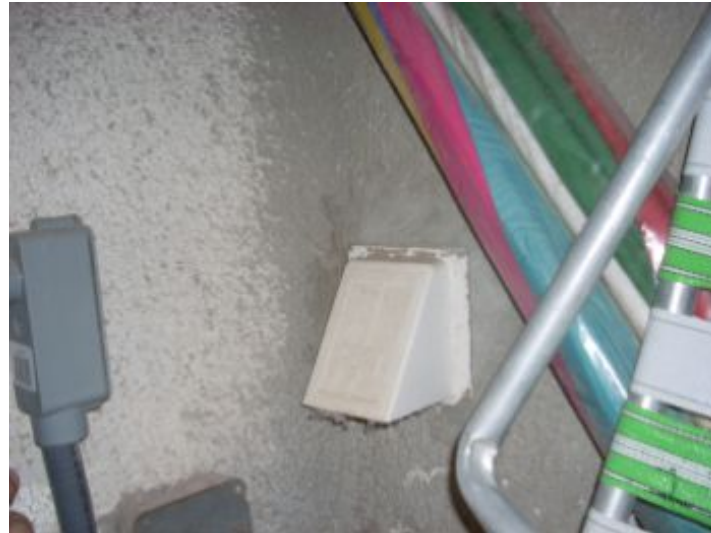
4. Dryer Vent

- The dryer vent terminates in enclosed closet.

Dryer vents to enclosed closet

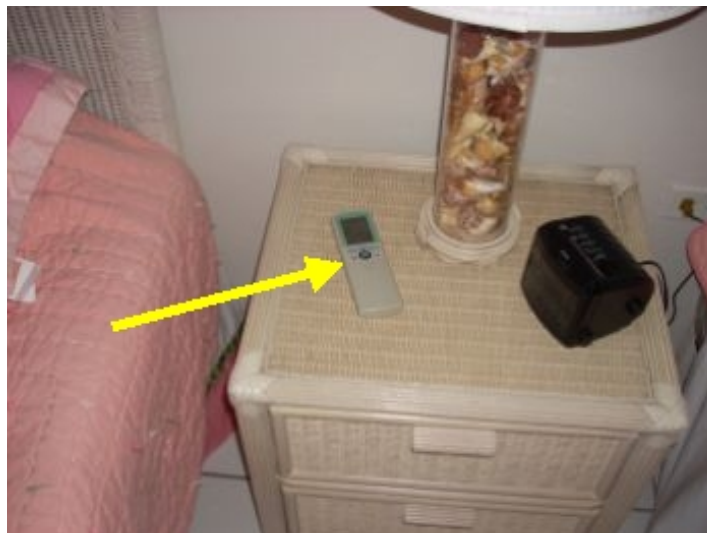
6. Thermostats

Observations:
 • Remote control theromstat in each bedroom in working order.

Example of remote for mini-split A/C

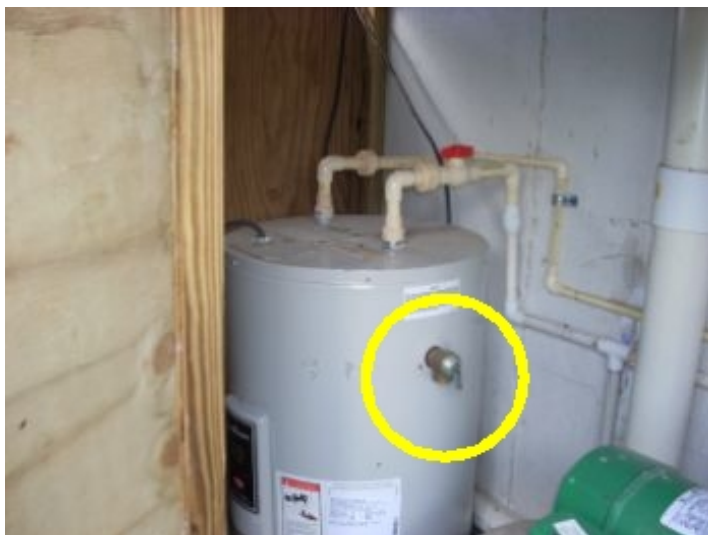
10. Overflow Condition

Materials: none
 Observations:
 • The extension at the water heater relief valve is missing. This is a potential scalding concern as water can discharge improperly. Recommend installing the proper type of relief extension to discharge within 6 to 8" from the floor.

No overflow tube

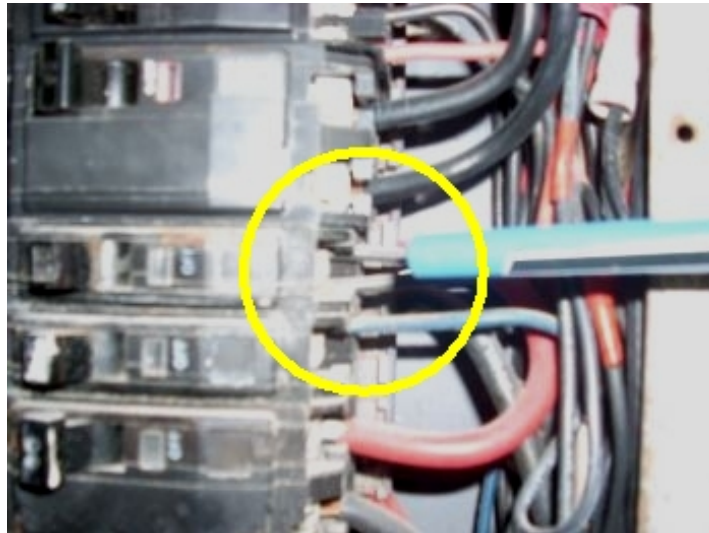
1. Electrical Panel

• Double tapped breaker(s) inside panel box (more than one electrical conductor attached). This is not standard practice, and may cause overheating or even an electrical fire. Recommend evaluation by an electrician. Double tapping and lugging can create hot spots on breakers and neutral bars because they are not tightened to the correct torque--especially if two different size conductors are used. Because the hot [black] and neutral [white] wires are both current carrying conductors, the chance is then greater for potential hot spots. If the double tap or lug becomes loose, it begins to arc. As it arcs it builds up carbon. Carbon is then resistance and with more carbon buildup the more difficult it is for the conductor to make contact, thus increasing the current. The end result can be the breaker tripping because of the loose connection [current exceeding the rating of the breaker], or signs of overheating such as discolored wires, melted wires, etc, or even fire.

Breaker is double tapped

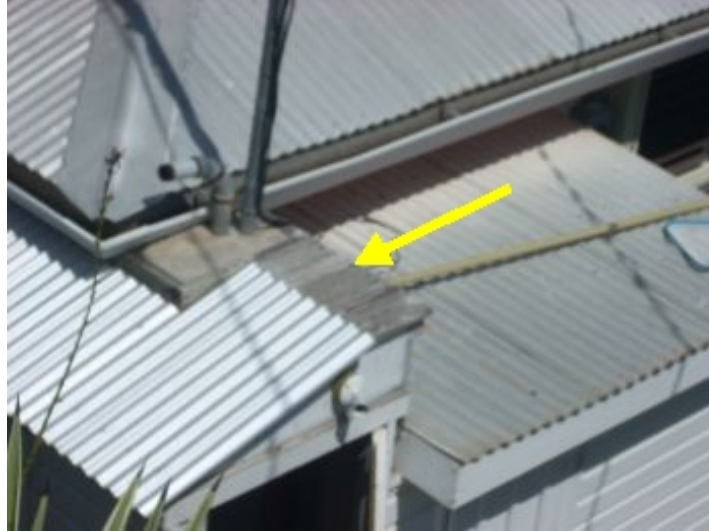
1. Roof Condition

- - Exposed plywood

Bare plywood on this surface

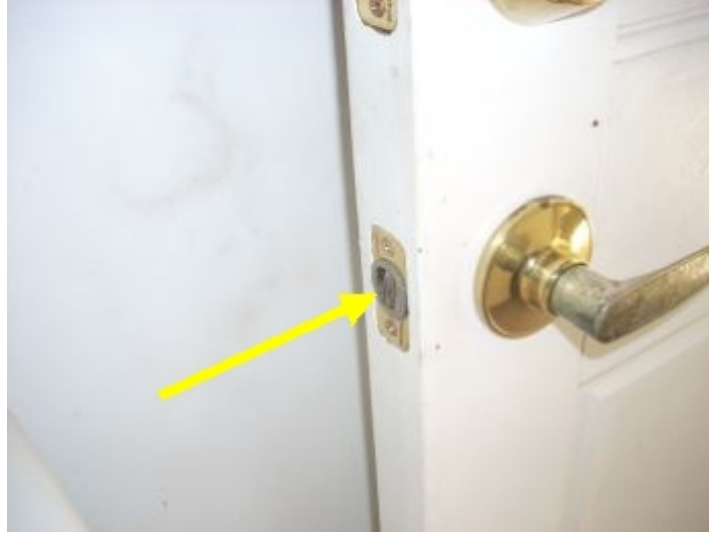
1. Doors

Kitchen door striker is stuck

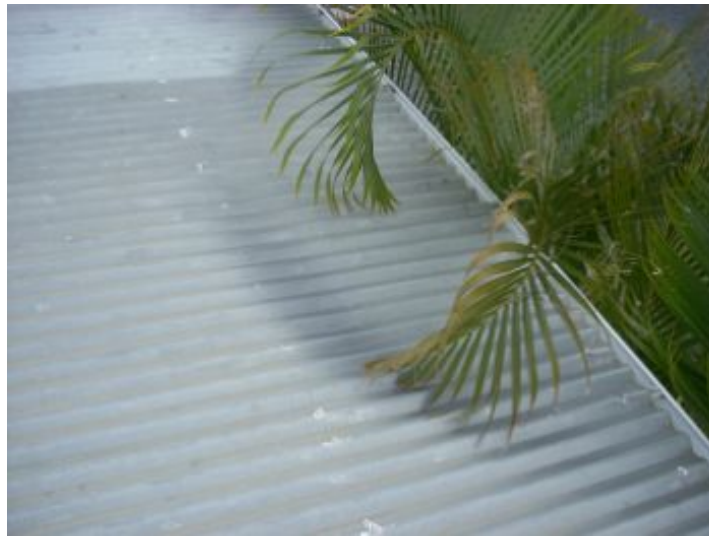
3. Vegetation Observations

- Tree limbs within 10 feet of roof should be trimmed away to provide air and sunlight to roof, while minimizing debris & dampness.

Trees overhanging roof should be trimed back

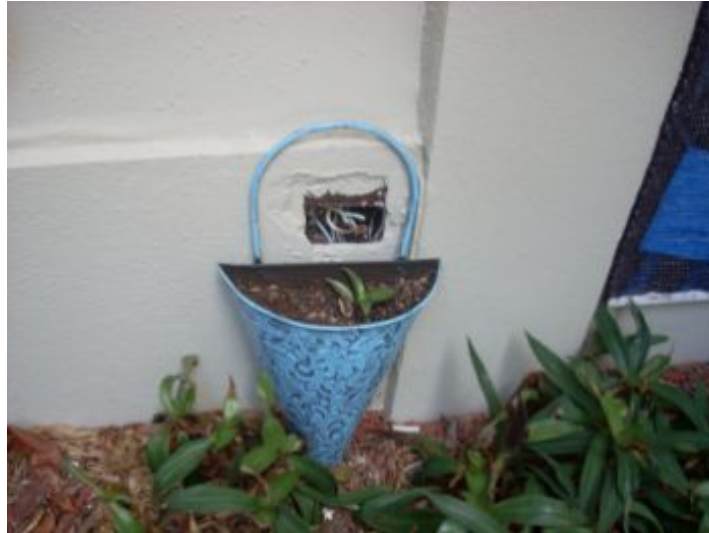
6. Grounds Electrical

Missing cover on junction box

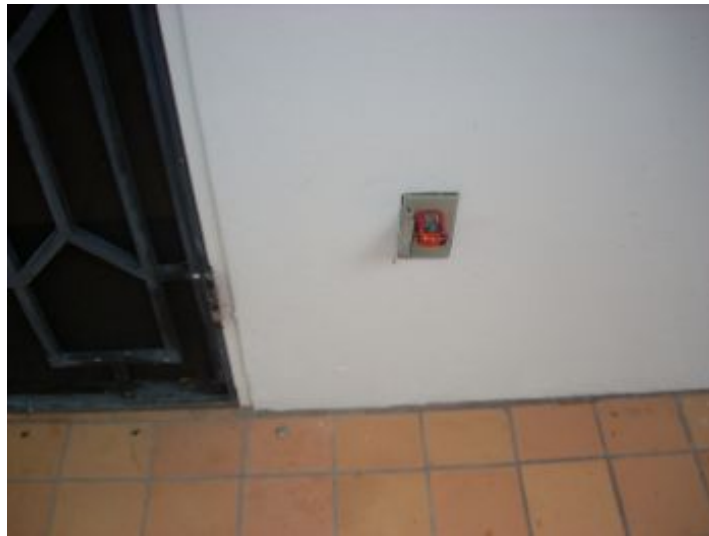
7. GFCI

Observations:
• none visible

No GFCI, no cover

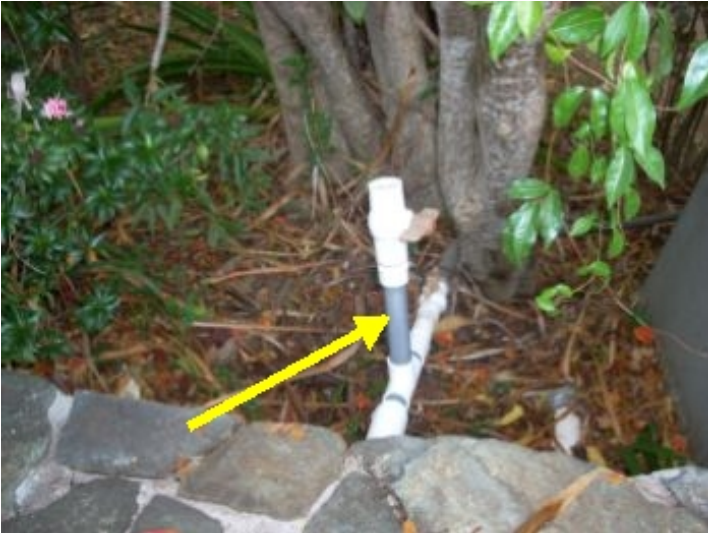
8. Plumbing

Supply line for hot tub made with electrical (gray) PVC

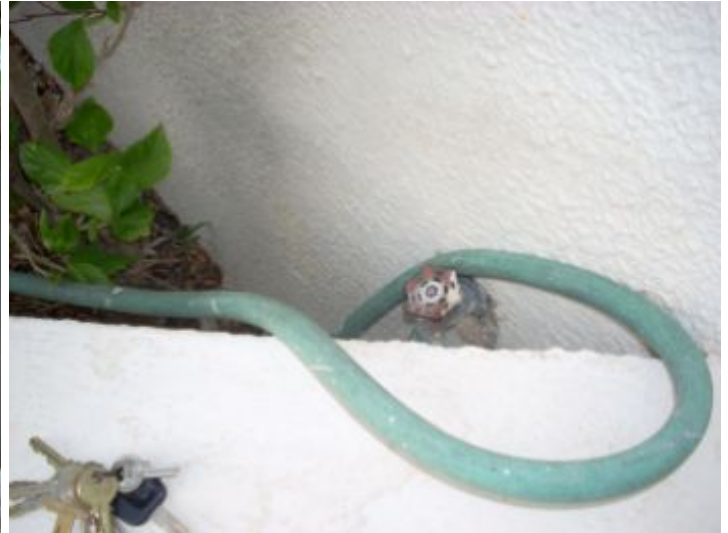
Hose bib at front of house
